Manhole Inspection Summary

Manhole # S3900_024MH

Insp Date: **3/27/07 11:46 AM**

Location Address: **2140 CURTAIN AVE**

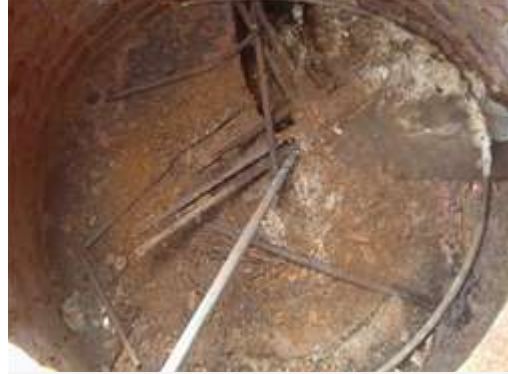
Top View

Adjustment and Barrel infiltration.
Evidence of surcharge - Bench debris.
Channel debris.

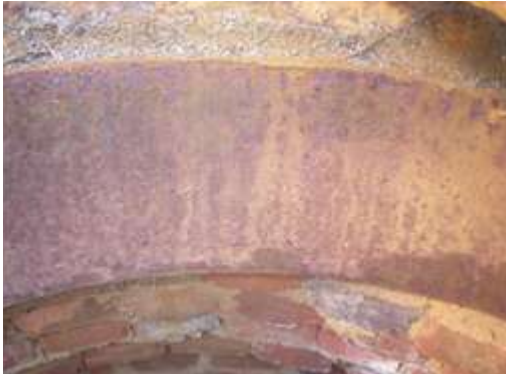
Defect

Corbel deterioration and infiltration.

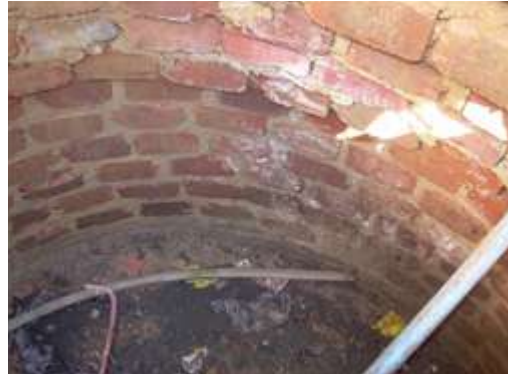
Defect

Corbel deterioration and infiltration. Barrel infiltration.

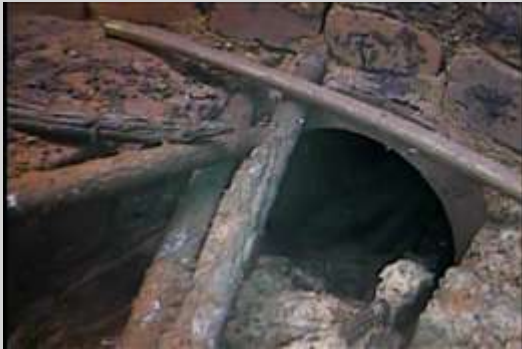
8 in. Circular Gravity Sewer Pipe Out @ 12 O'Clock

Deposits: ☐ None ☐ **Mud** ☐ Sludge ☒ **Debris** ☐ Grease

Silt Depth: **1** (in.) Deposits Extent: **Light**

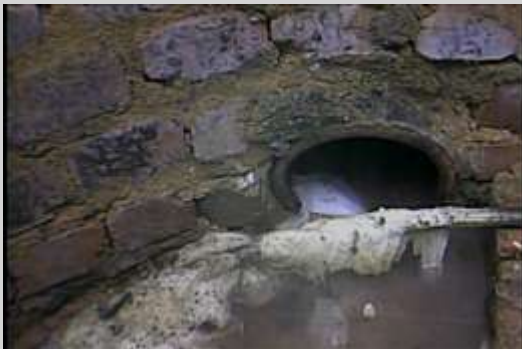
8 in. Circular Gravity Sewer Pipe In @ 3 O'Clock

Deposits: ☐ None ☒ **Mud** ☐ Sludge ☒ **Debris** ☐ Grease

Silt Depth: **1** (in.) Deposits Extent: **Light**

Infiltration: **Evidence** Pipe Seal Cond: **Unknown**
